DOT/FAA/AR-96/10

The Role of Fretting Fatigue on Aircraft Rivet Hole Cracking

October 1996

Final Report

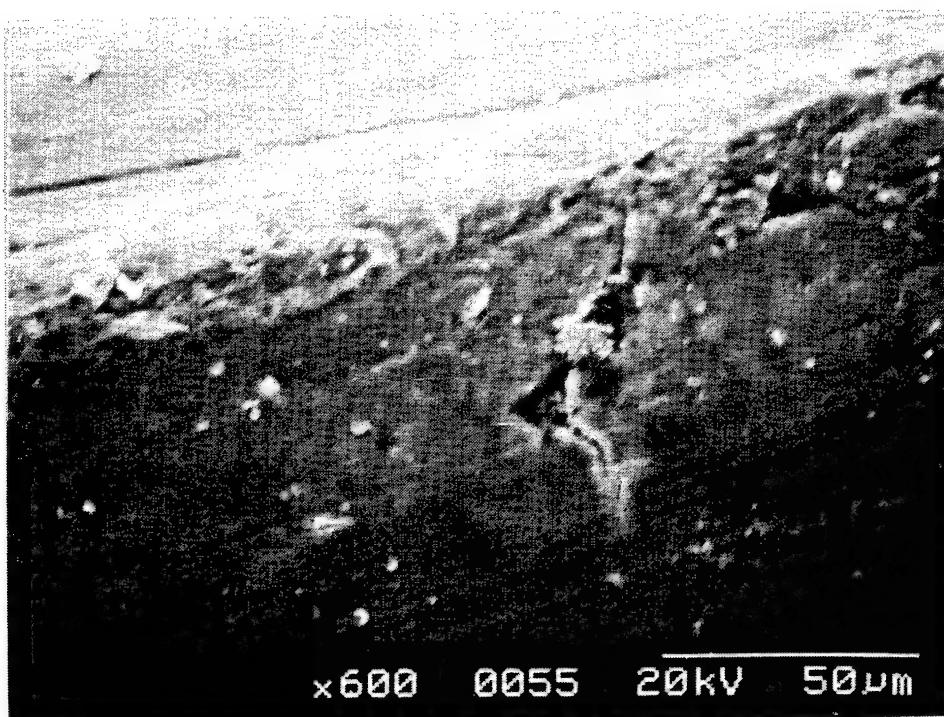
Several cracks were found in regions that appeared to have had relatively little fretting damage. However, these cracks were generally attributable to other identifiable causes such as the crack emanating from a void or inclusion as shown in figure 20.

Figure 20. Crack emanating from a void or inclusion in a relatively unfretted region in rivet hole 49.

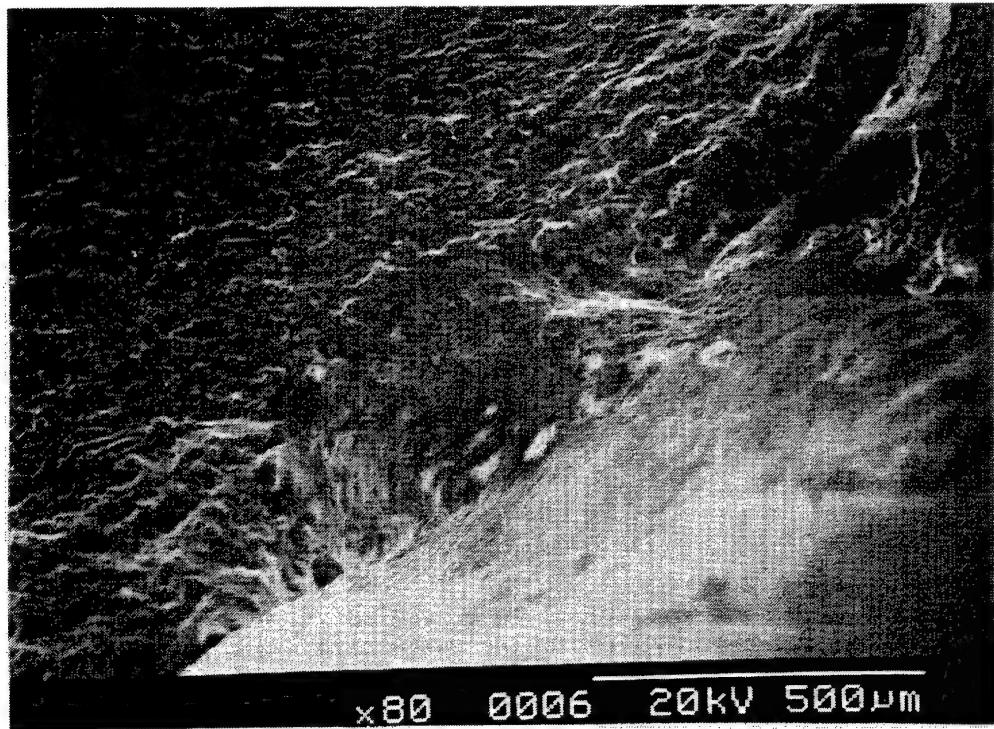
Figure 27. Fracture surface of a crack which nucleated within a region subject to fretting.
The fretting is at location CE5 of figure 25.
